**Bunker Hill Mine Flood-Stanly
Ore Body In-Mine
Reconnaissance Report**

**Bunker Hill Mine Water
Presumptive Remedy**

Prepared for
**U.S. Environmental Protection Agency
Region 10**

Bunker Hill Mine Flood-Stanly Ore Body In-Mine Reconnaissance Report (Supplement 2 to the Presumptive Remedy Conceptual Model)

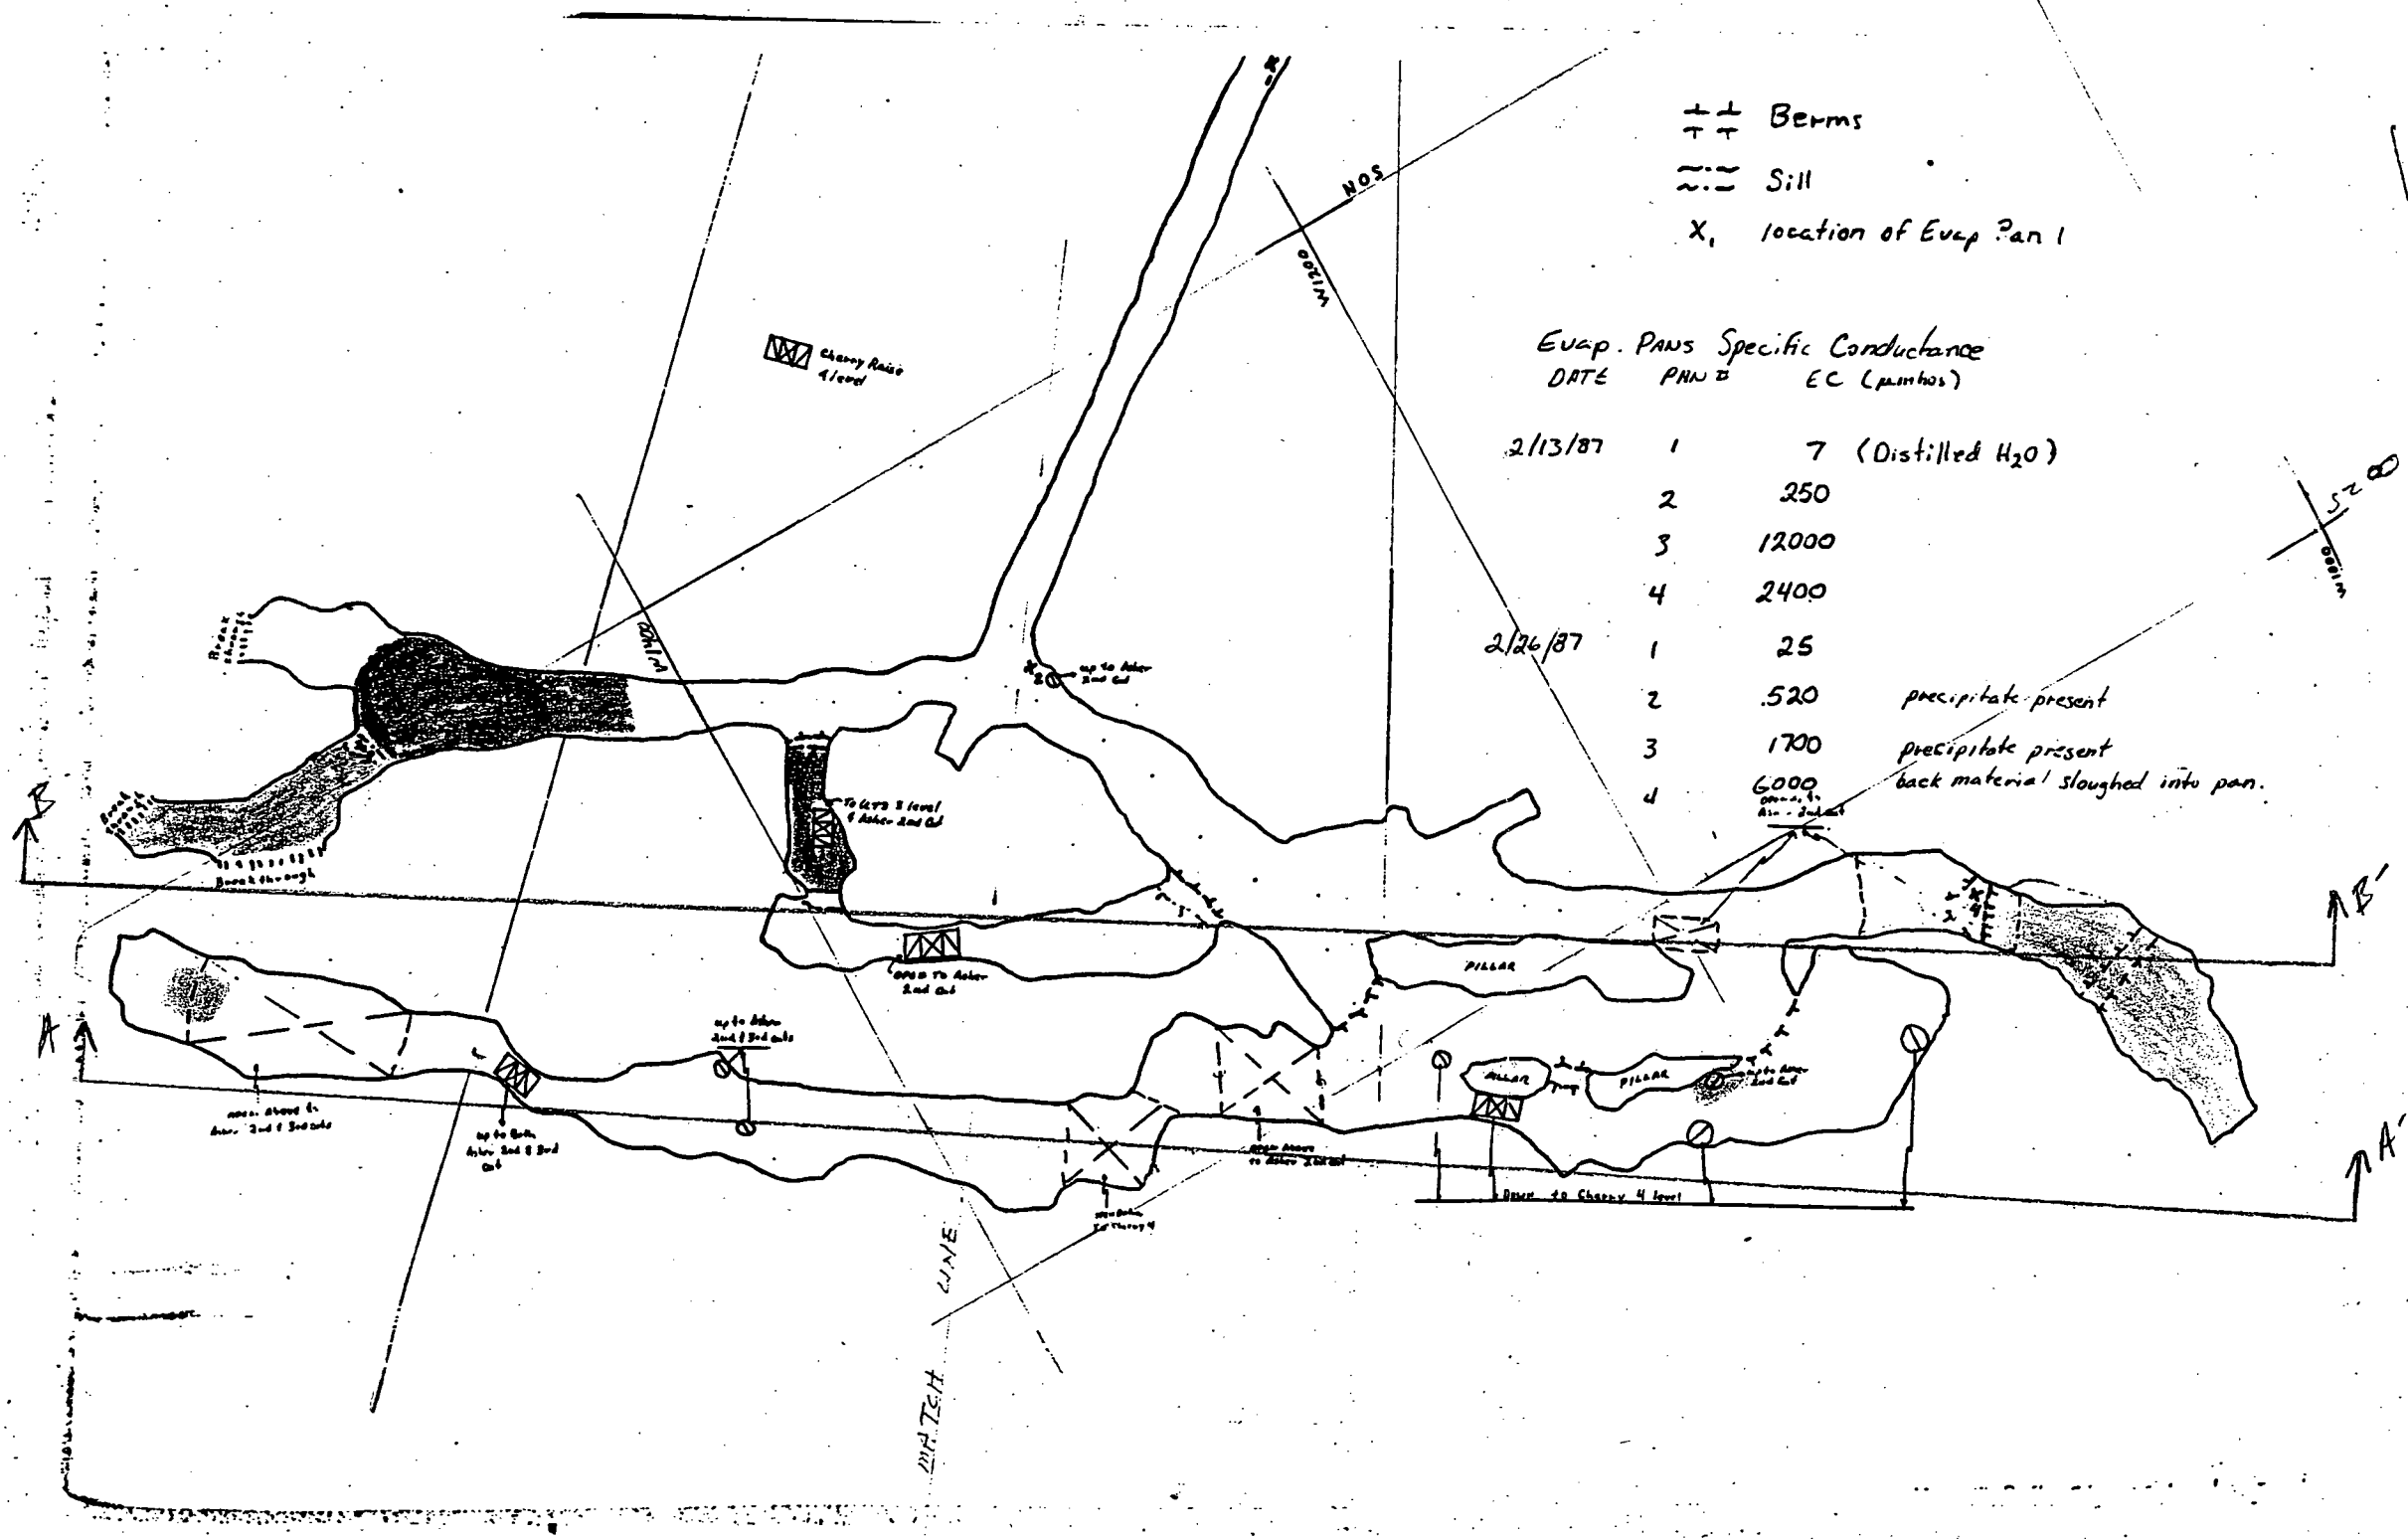
FIGURE 2

The Utz workings are the highest and shallowest workings that are accessible in the vicinity of the Flood-Stanly ore body. Water recharges the Utz from the surface along preferential fracture flow paths. Most of the water that enters the Utz workings flows into the sub-levels below, and eventually into the Homestake workings. Some water at the western end of the Utz enters an open stope and drains to the Cherry 4 workings. These flow paths consist of fractures, stopes, transfer chutes, raises, and other man-made openings. Recharge to the Homestake workings consists of drainage from the overlying Utz, and groundwater recharge via fractures.

The Utz and Homestake workings are developed in or near the hanging wall of the Cate Fault. The ore zones consist of fine grained, gray gouge material that contains large amounts of disseminated pyrite as well as economic minerals. Generally, the pyrite is very fine-grained gray material, but some large (6 inch diameter) assemblages occur.

All of the water from the Homestake workings discharges to the sub-level below via fractures, transfer chutes, raises and other man-made openings. From that sub-Level, the water discharges into an open stope. This was mistakenly identified as a caving area in Bretherton (1990). The bottom of this stope is approximately at 4 1/2 Level. The water from the Homestake appears to discharge from fractures, drill holes, and rock bolt holes at the end of the Asher drift on 5 Level. Tracer testing or other methods would be required to confirm this.

One concept would be to bulkhead the end of drifts on the sub-level below the Homestake and backfill all of the workings from that level up to the top of the sub-levels above the Utz. It may be simpler to mine the shallow veins in the Utz to the surface than to monitor placement of backfill to insure good distribution in the shallowest workings. This approach should be contrasted to surface capping because of the steep topography and heavy surface vegetation. However, neither option should be excluded at this time.

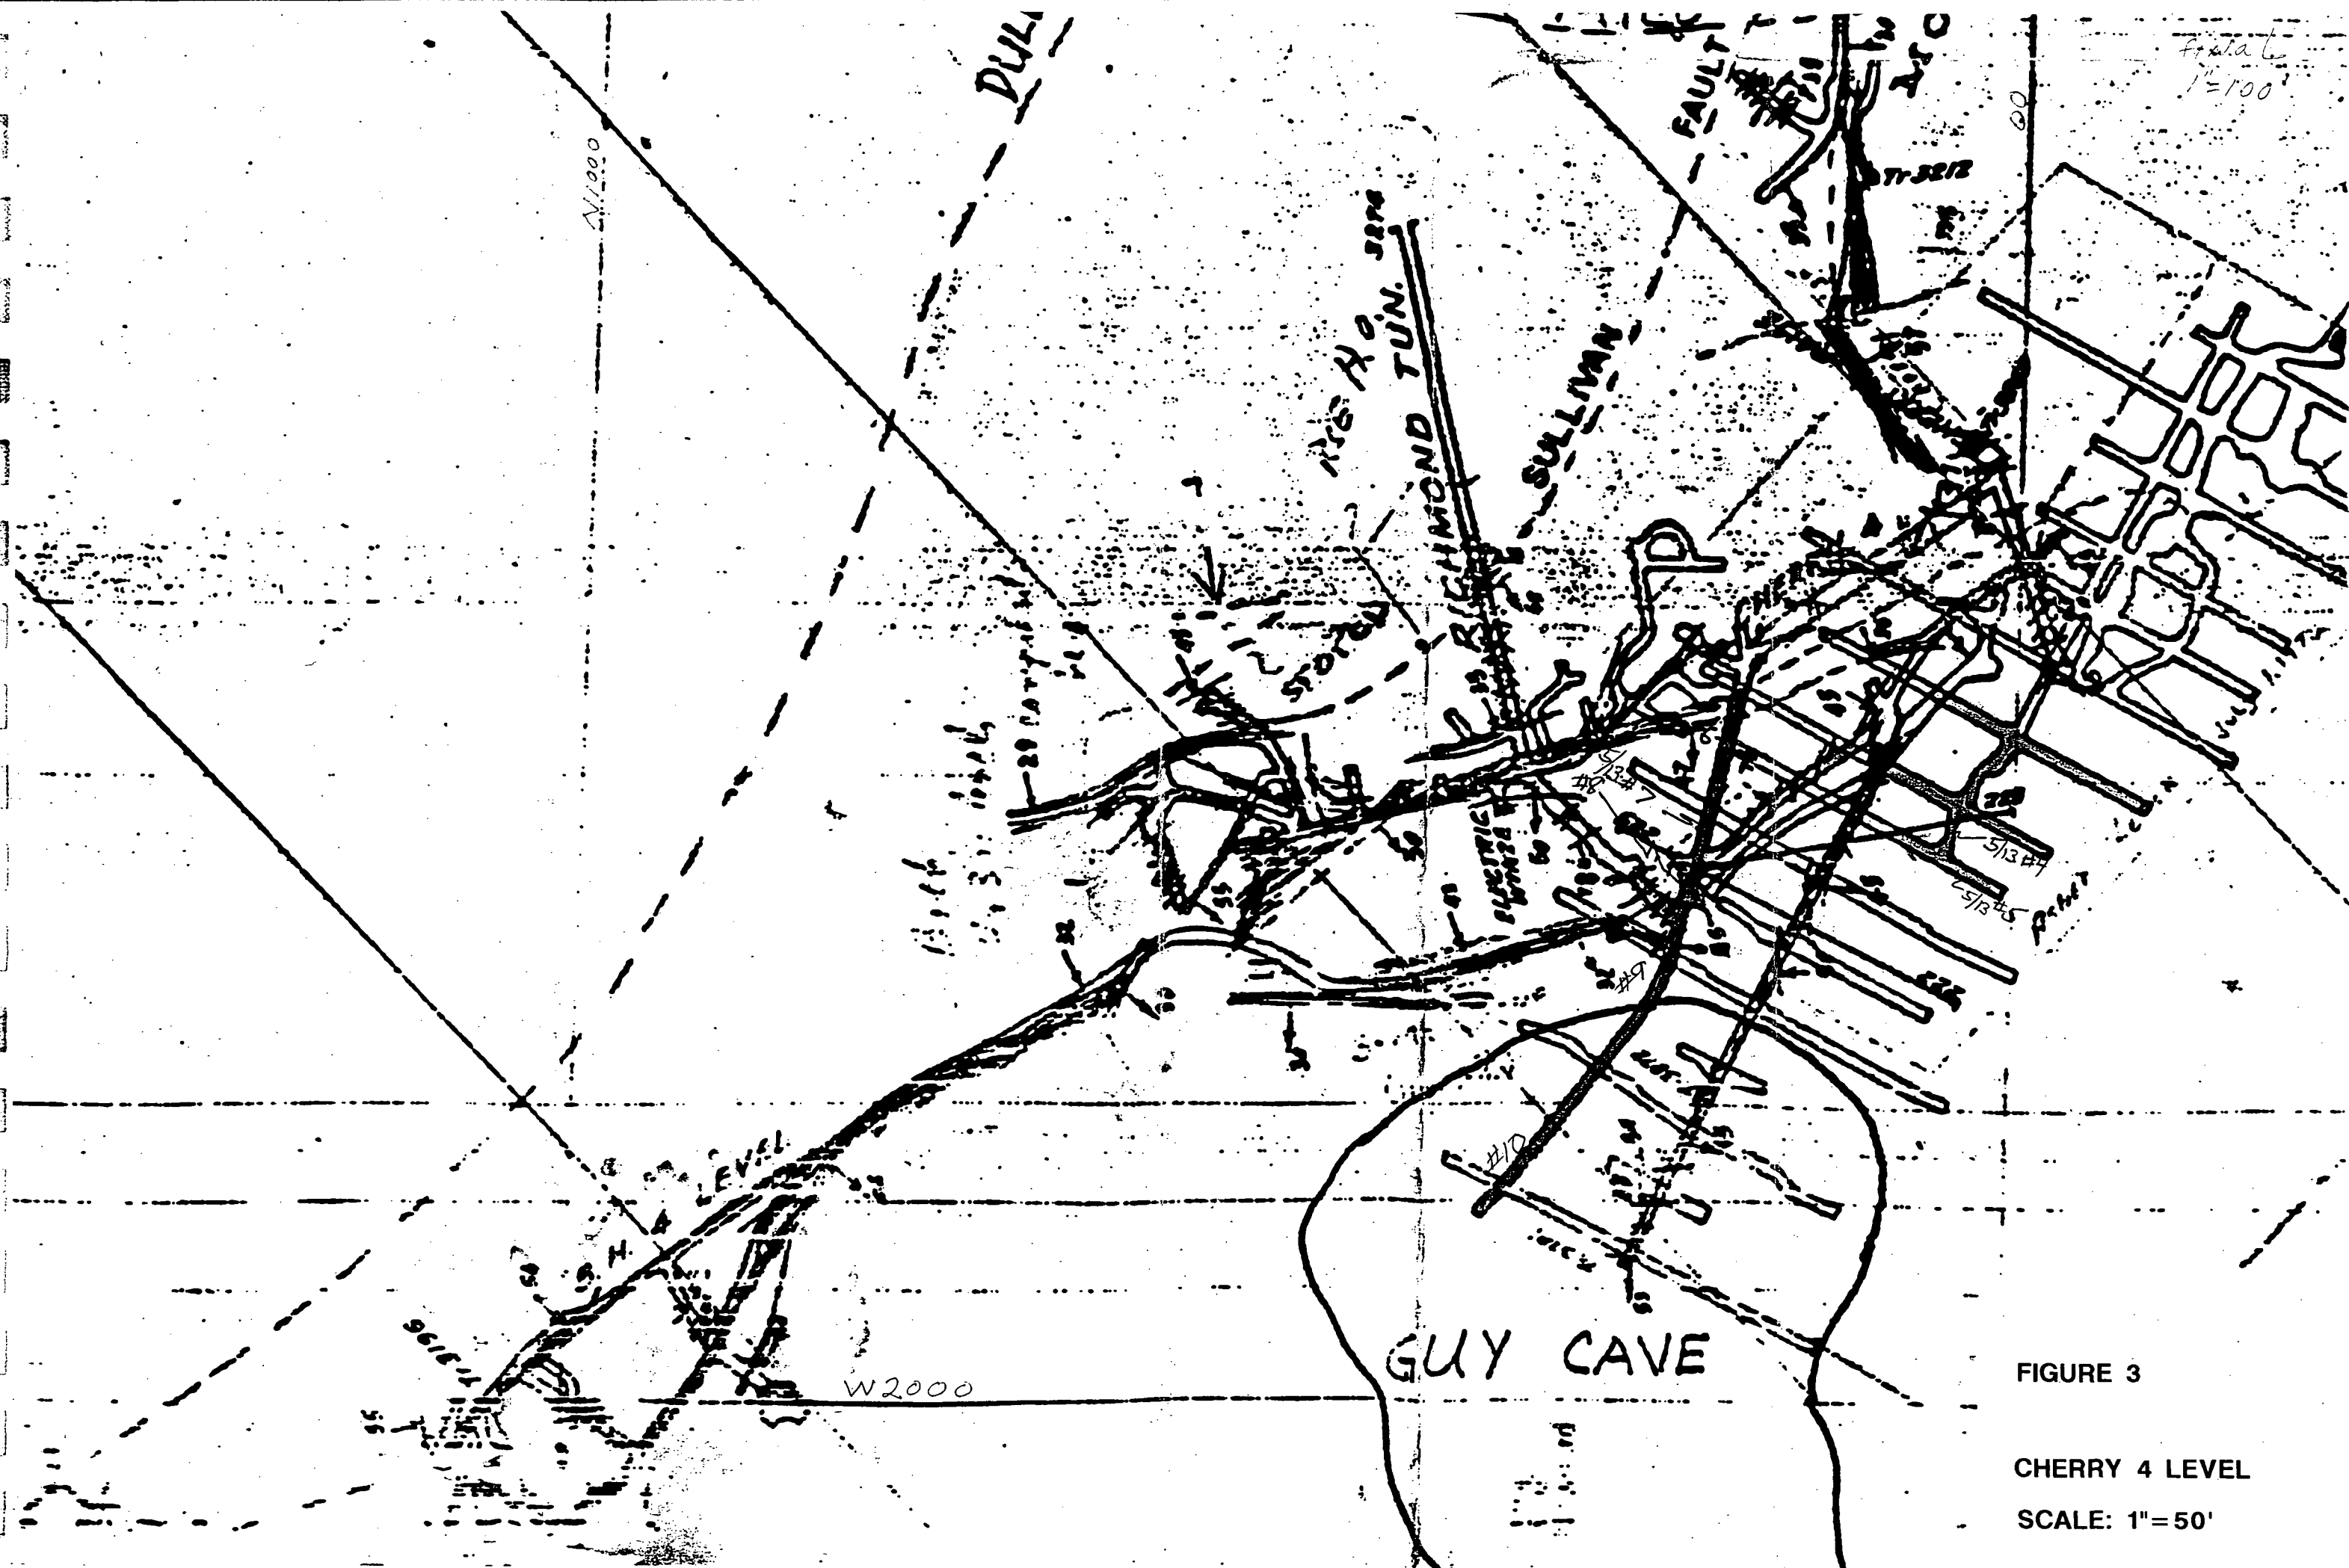
FIGURE 3

The Cherry 4 working are adjacent to and approximately 20 feet lower than the sublevel below the Homestake workings. Part of the Cherry 4 was developed during the block caving of the Flood-Stanly; other parts were developed later during the mining of the Utz and Homestake. Recharge to Cherry 4 consists of groundwater recharge via fractures, rock bolt holes, drill holes, and drainage from overlying workings via raises, transfers, and stopes.

The quality of recharge water is good in a few locations. Generally, however, the water quality is fair to poor, because of flow through pyrite-rich ore zones and ponding in contact with pyrite-rich muck. The range of EC is from 3,000 to 30,000 $\mu\text{S}/\text{cm}$.

Discharge from Cherry 4 consists of drainage through transfers and collapsed ground, and into stopes. The water flows generally to the western parts of 5 Level in the vicinity of the underground greenhouse. Cross sections of the Utz, Homestake, and Cherry 4 are presented in Figures 6 and 7. Please refer to Figures 1, 2, and 4 for the cross section locations.

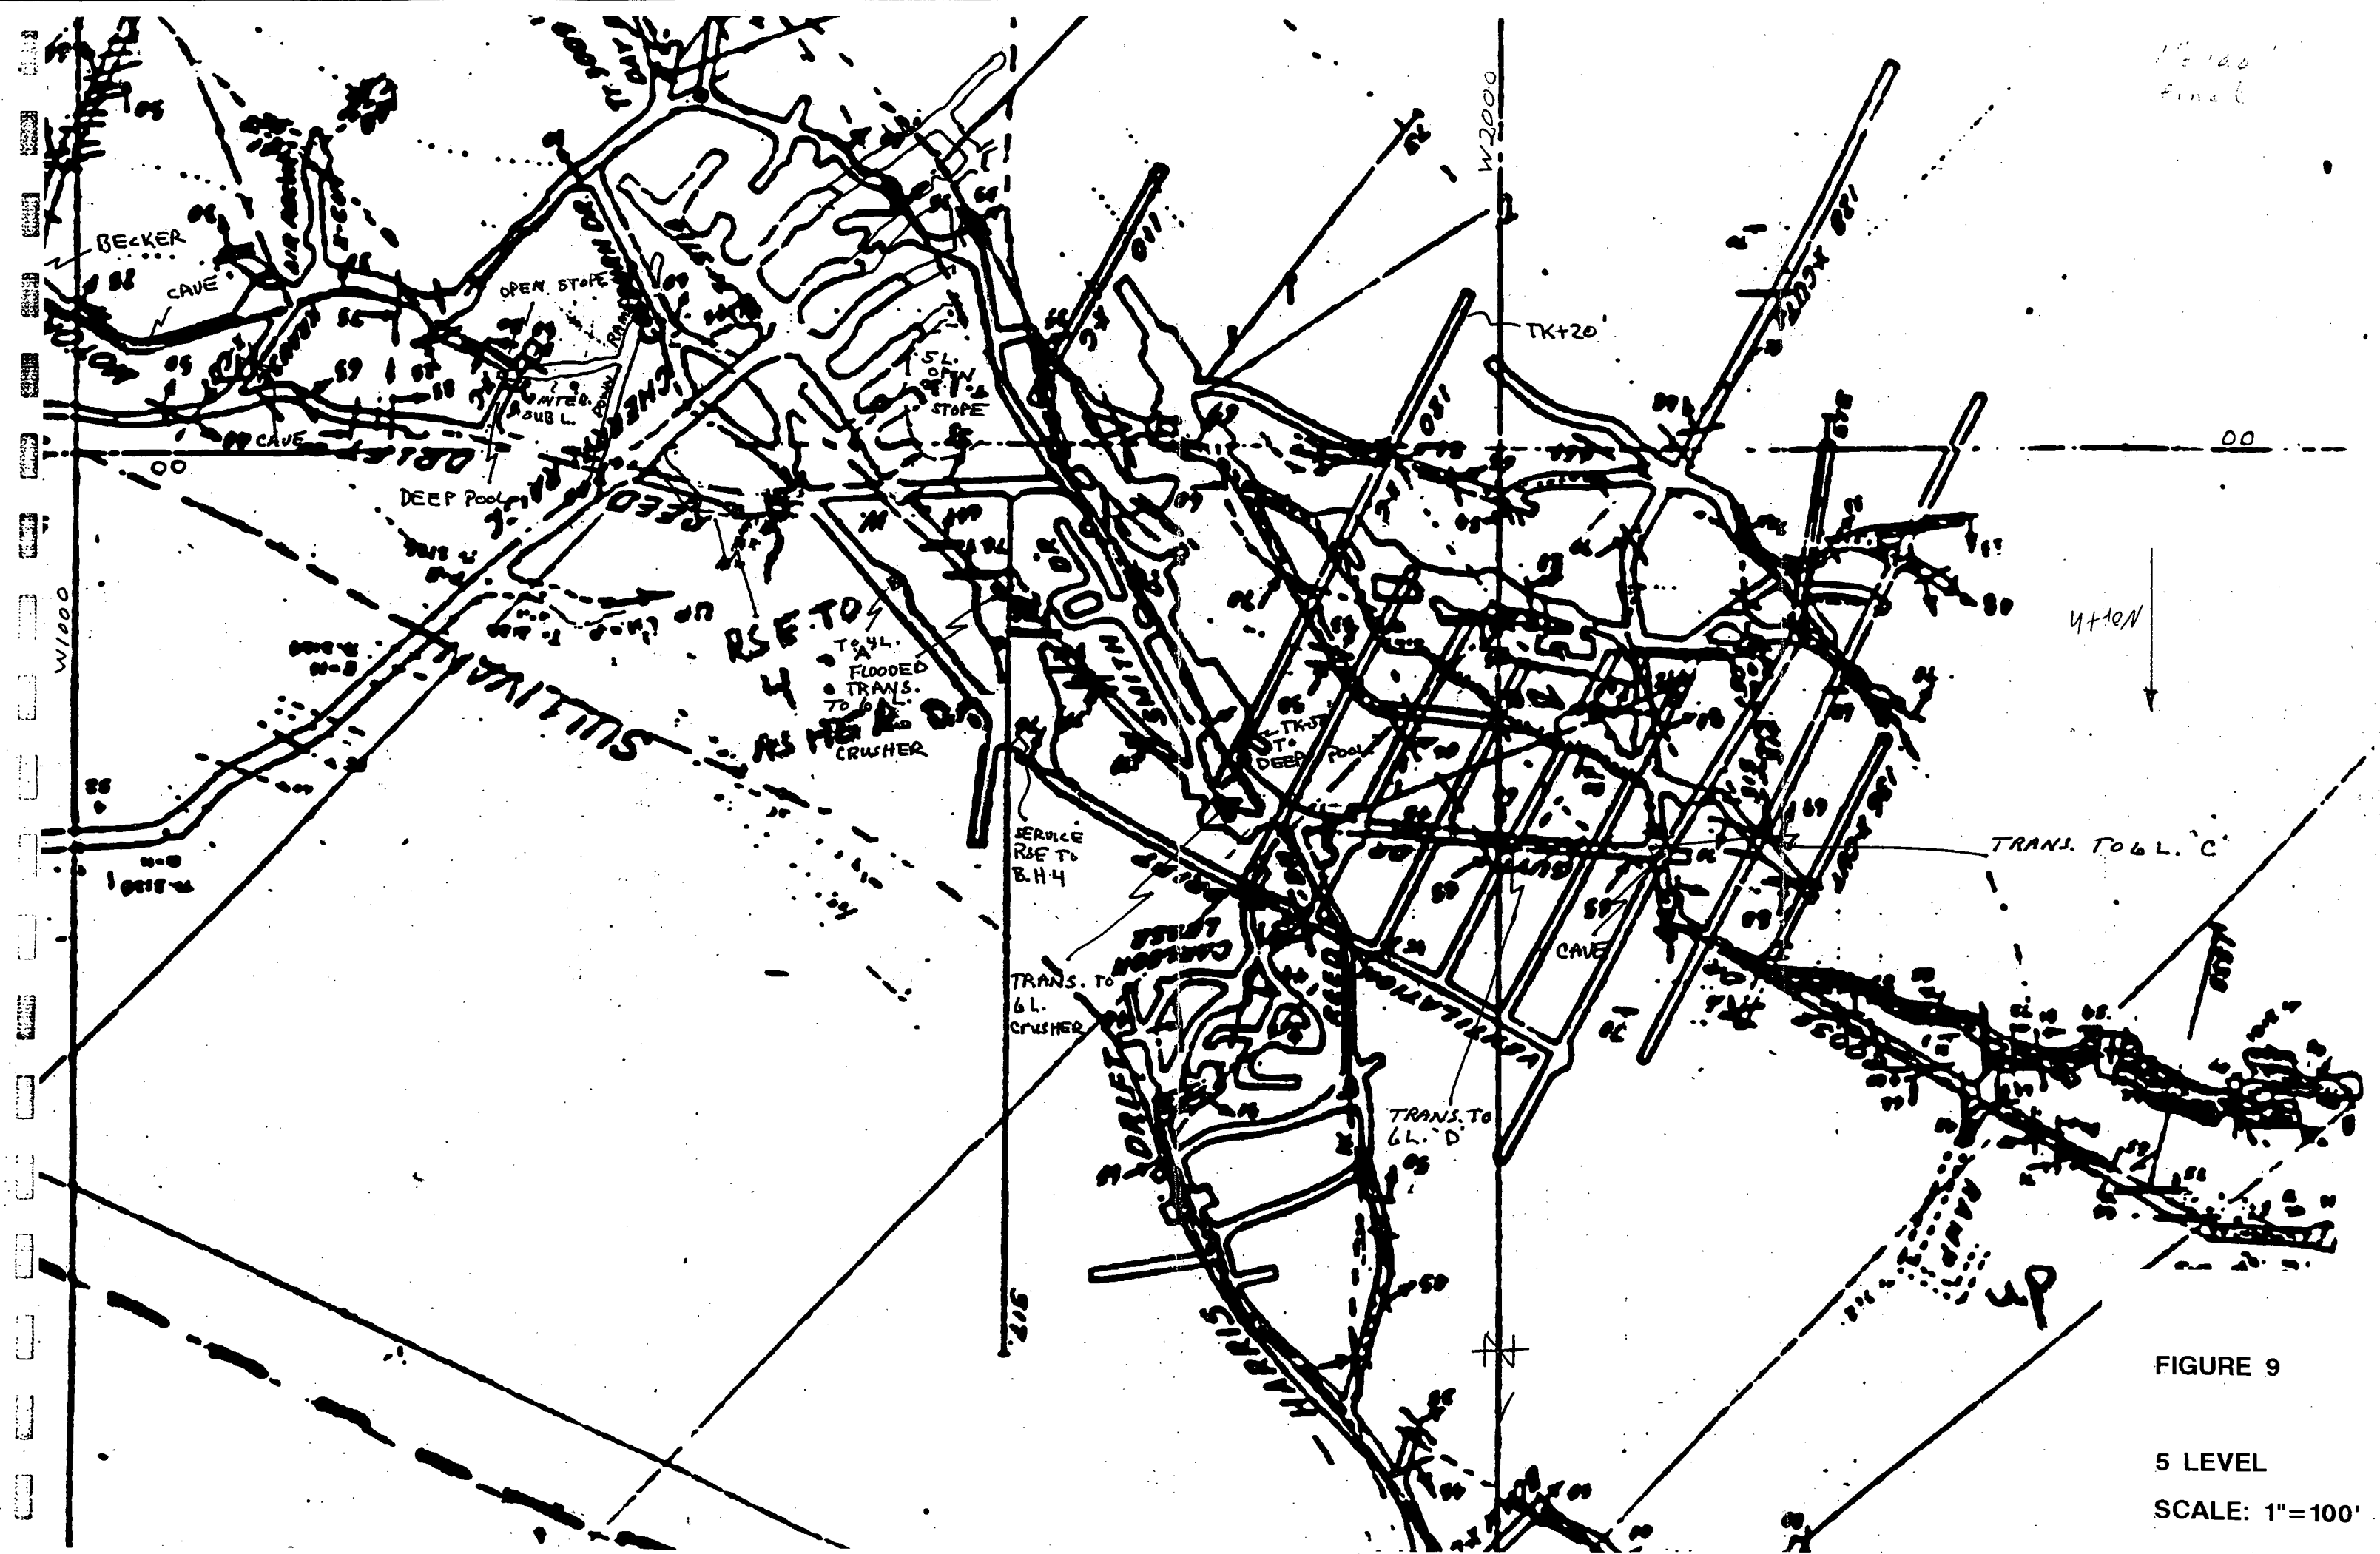
FIGURE 9

Recharge to 5 Level workings consists of groundwater recharge via fractures, rock bolt holes, drill holes, and drainage from overlying workings via raises, transfers, and stopes.

Tributary flows to the underground greenhouse include drainages from fractures, transfer raises, and manways. Water flows vertically from Cherry 4 and Bunker Hill 4 workings and laterally from groundwater recharge through fractures.

The quality of groundwater recharge is good to excellent ($EC < 200 \mu S/cm$). Drainage from overlying workings varies from excellent to poor (EC from 66 to 44,000 $\mu S/cm$).

Water draining from the stope identified in the discussion of the Homestake workings, plus water from other fracture systems, flows through drawpoints at the end of the Asher Drift to a ramp down to the 5 Level Reed workings. This ramp was developed during the late stages of Bunker Limited Partnership operations (1990's), and is not shown on any existing mine maps. The flow divides, with a small portion draining toward the greenhouse, and flowing through the monitoring station at 5WR. The majority of this water flows toward the West Motor Drift through a pond that is too deep to walk through with hip boots. Presumably, the water somehow reaches the Mule Raise between 5 and 6 Level. Access via the West Motor drift is blocked slightly beyond the Mule Raise by a cave in, so physical verification was impossible.

The majority of drainage from the Flood-Stanly Ore Body and Guy Caving operations (west side of 5 Level) flows from the underground greenhouse to the West Reed Flume (5WR) where it is monitored. The water continues along the West Reed drift, where discharge from transfer chutes improves the water quality slightly. It flows to the Becker Flume (5BK) through a breakthrough into the Motor Vein, and eventually to the Mule Raise near 6 level. Some of the water from the greenhouse drains directly down to 6 Level, in the vicinity of the underground crusher station, via ore transfer chutes, service raises, and possibly collapsed ground. The water near the 6 Level crusher station is directly tributary to the Stanly Ore Chute on 9 Level, or the Cherry Raise which drains to 9 level.

Discharge from the greenhouse is generally less than 10 gallons per minute (gpm), but the water quality is very poor. EC is generally greater than 10,000 $\mu S/cm$, with a maximum of 44,600 $\mu S/cm$. Discharge from fractures and ore chutes improves the water quality between the greenhouse and the Becker Flume. EC ranges from less than 100 to 4,700 $\mu S/cm$.

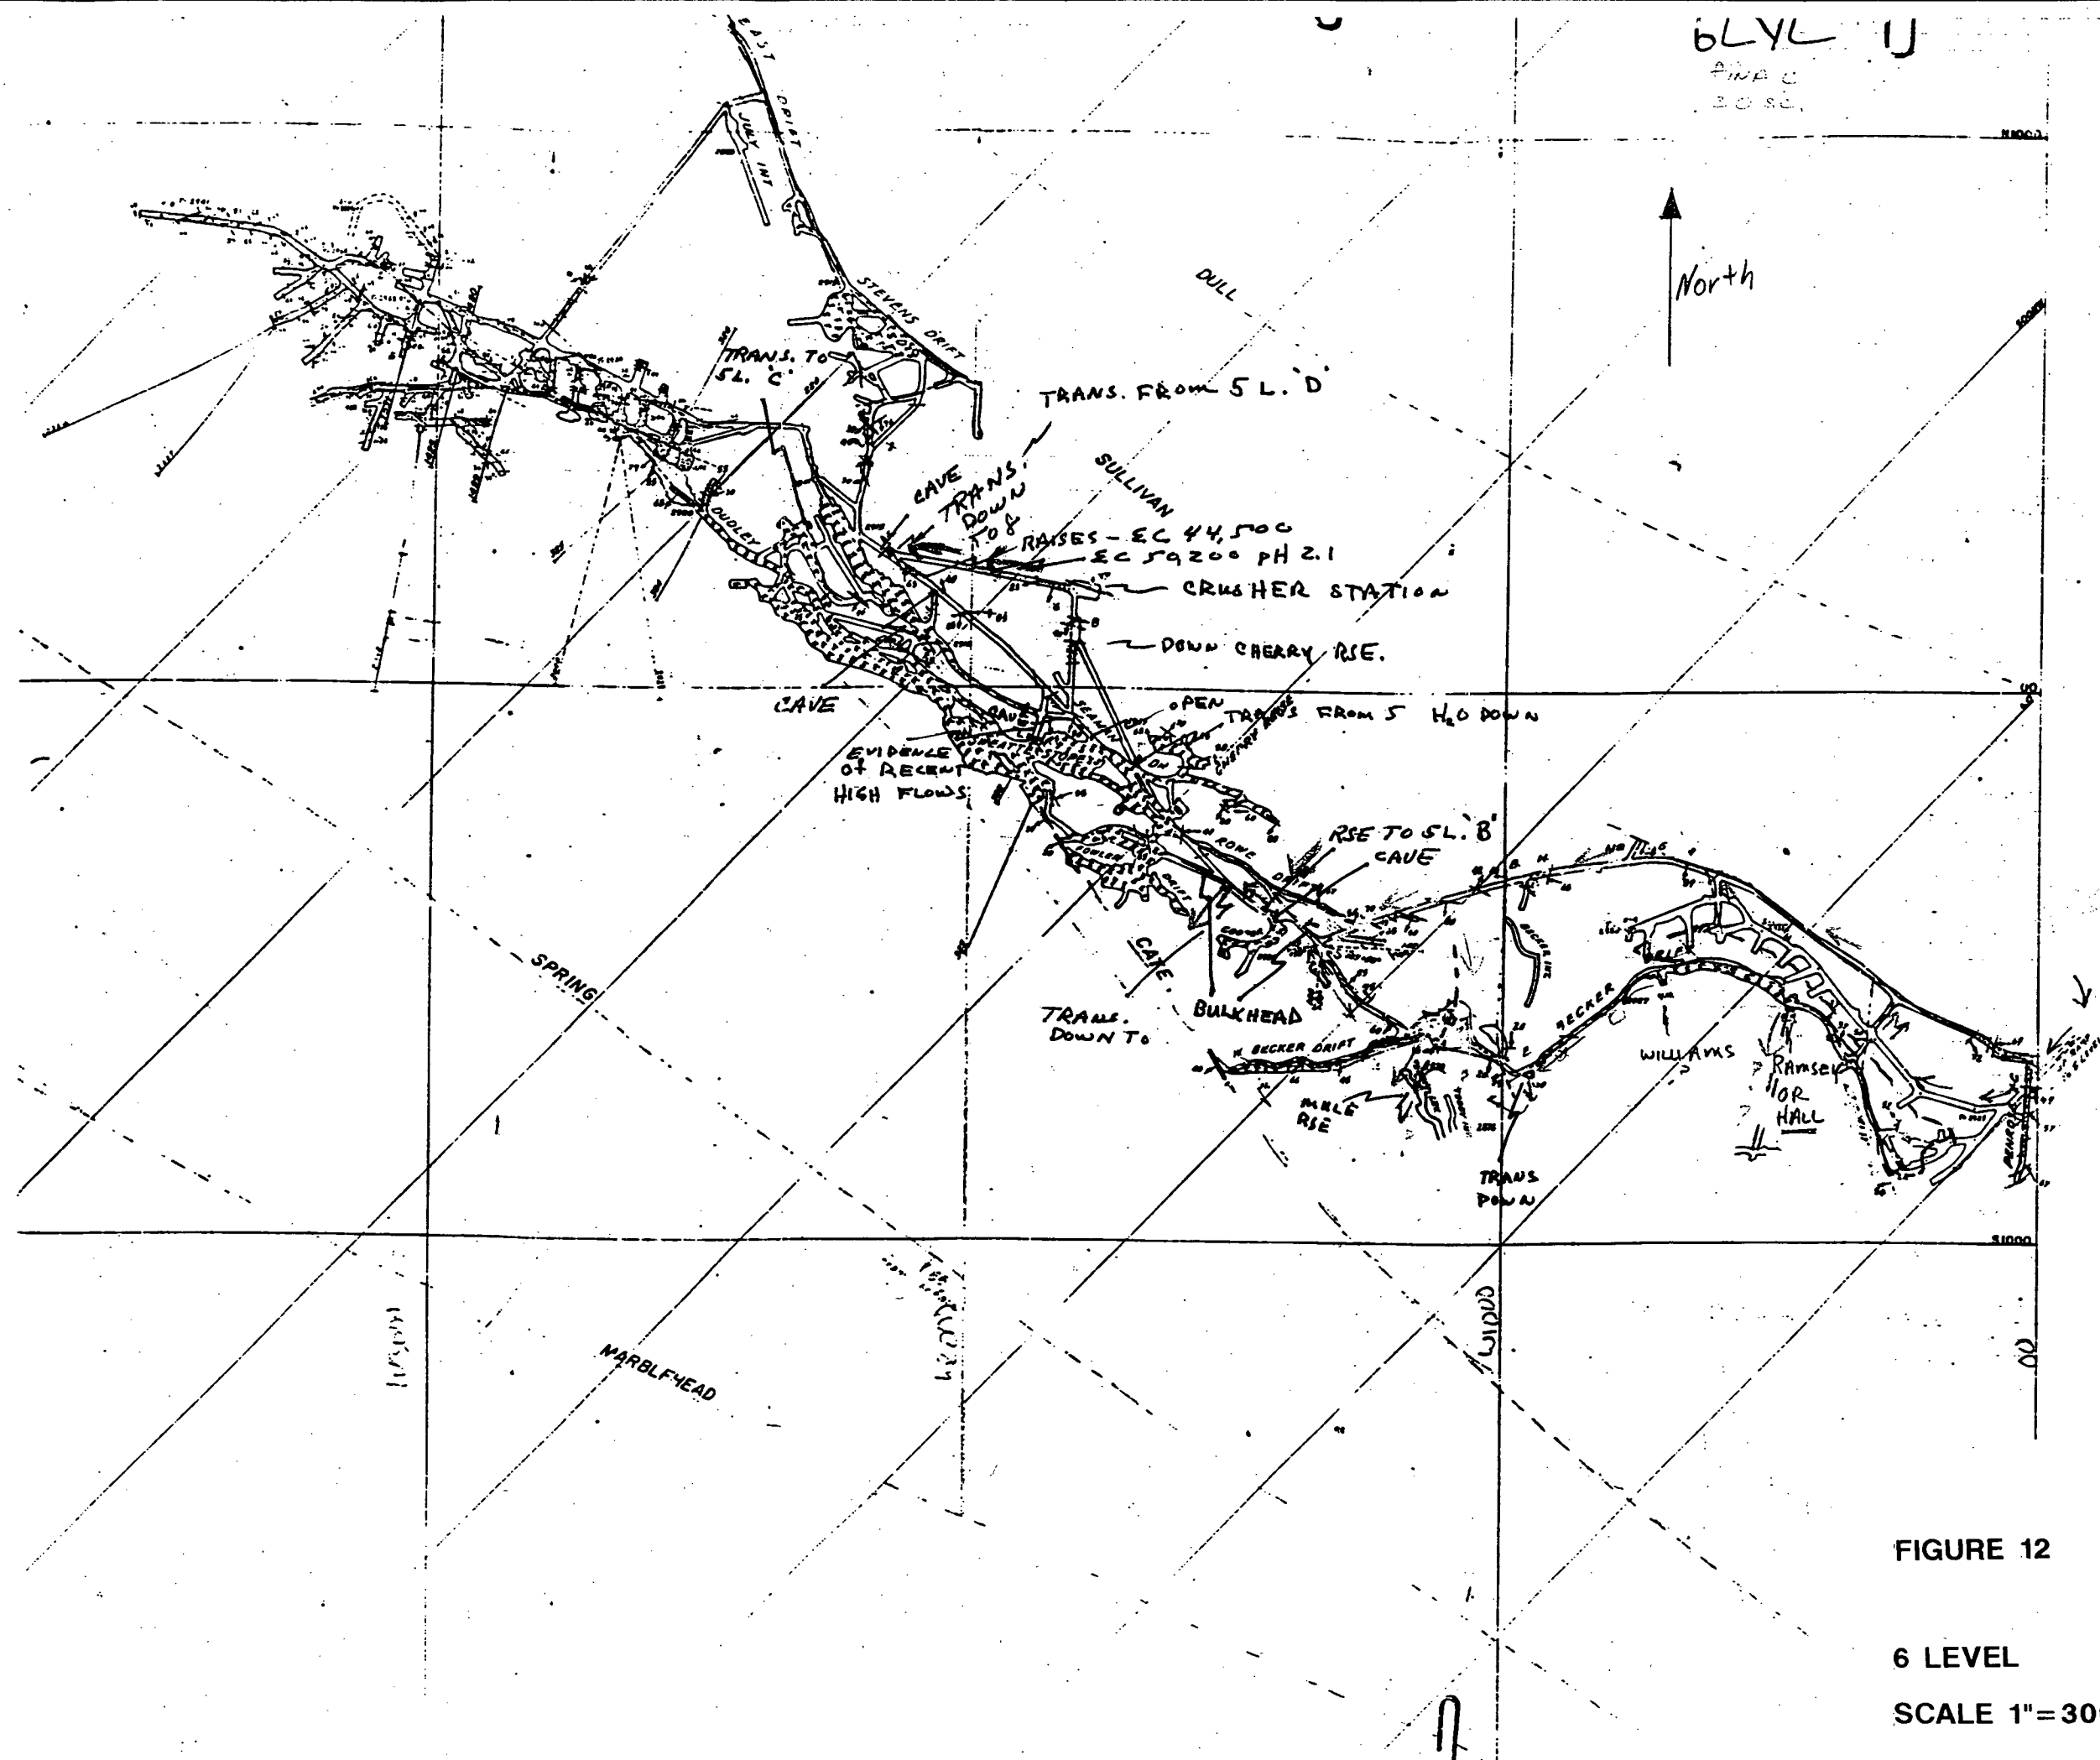
FIGURE 12

Discharge from 5 Level, via the Becker (Mule) Raise and Williams Winze, constitutes the majority of flow on 6 Level. Other sources include recharge from fractures and transfers in the greenhouse, drainage down the ramp from the New East Reed drift on 5 Level, drainage from stopes - primarily the Hanna Stope, and recharge of groundwater.

Water from the west side of 5 Level (5BK) reaches the Mule Raise on 6 Level. Water from the east side of 5 Level (5WM) flows down the Williams Winze to 6 Level. That water flows across 6 Level to a large transfer located east of the Mule Raise. Both of these flows presumably reach 7 Level and eventually reaches the Van Raise and discharges to the 9 Level Bunker Hill East Drift, and is monitored at 9 VR. Physical verification of the flow paths below 6 1/2 Level was not possible. The Mule Raise becomes very steep, and existing ladders were badly corroded; access to 7 Level from the Cherry Raise was blocked.

The underground crusher station was constructed for service during the Guy Caving operations in the late 1940's and early 1950's. Consequently, many ore transfers from overlying Guy Caving workings are tributary to the crusher. The ore was crushed and transferred to 9 Level via ore chutes to the Stanly Crosscut.

A flow divide exists near the underground crusher station on 6 Level. A portion of that water flows east to the Cherry Raise and down to 9 Level. The remaining water flows west to the ore transfers that are tributary to the Stanly Crosscut, also on 9 Level.

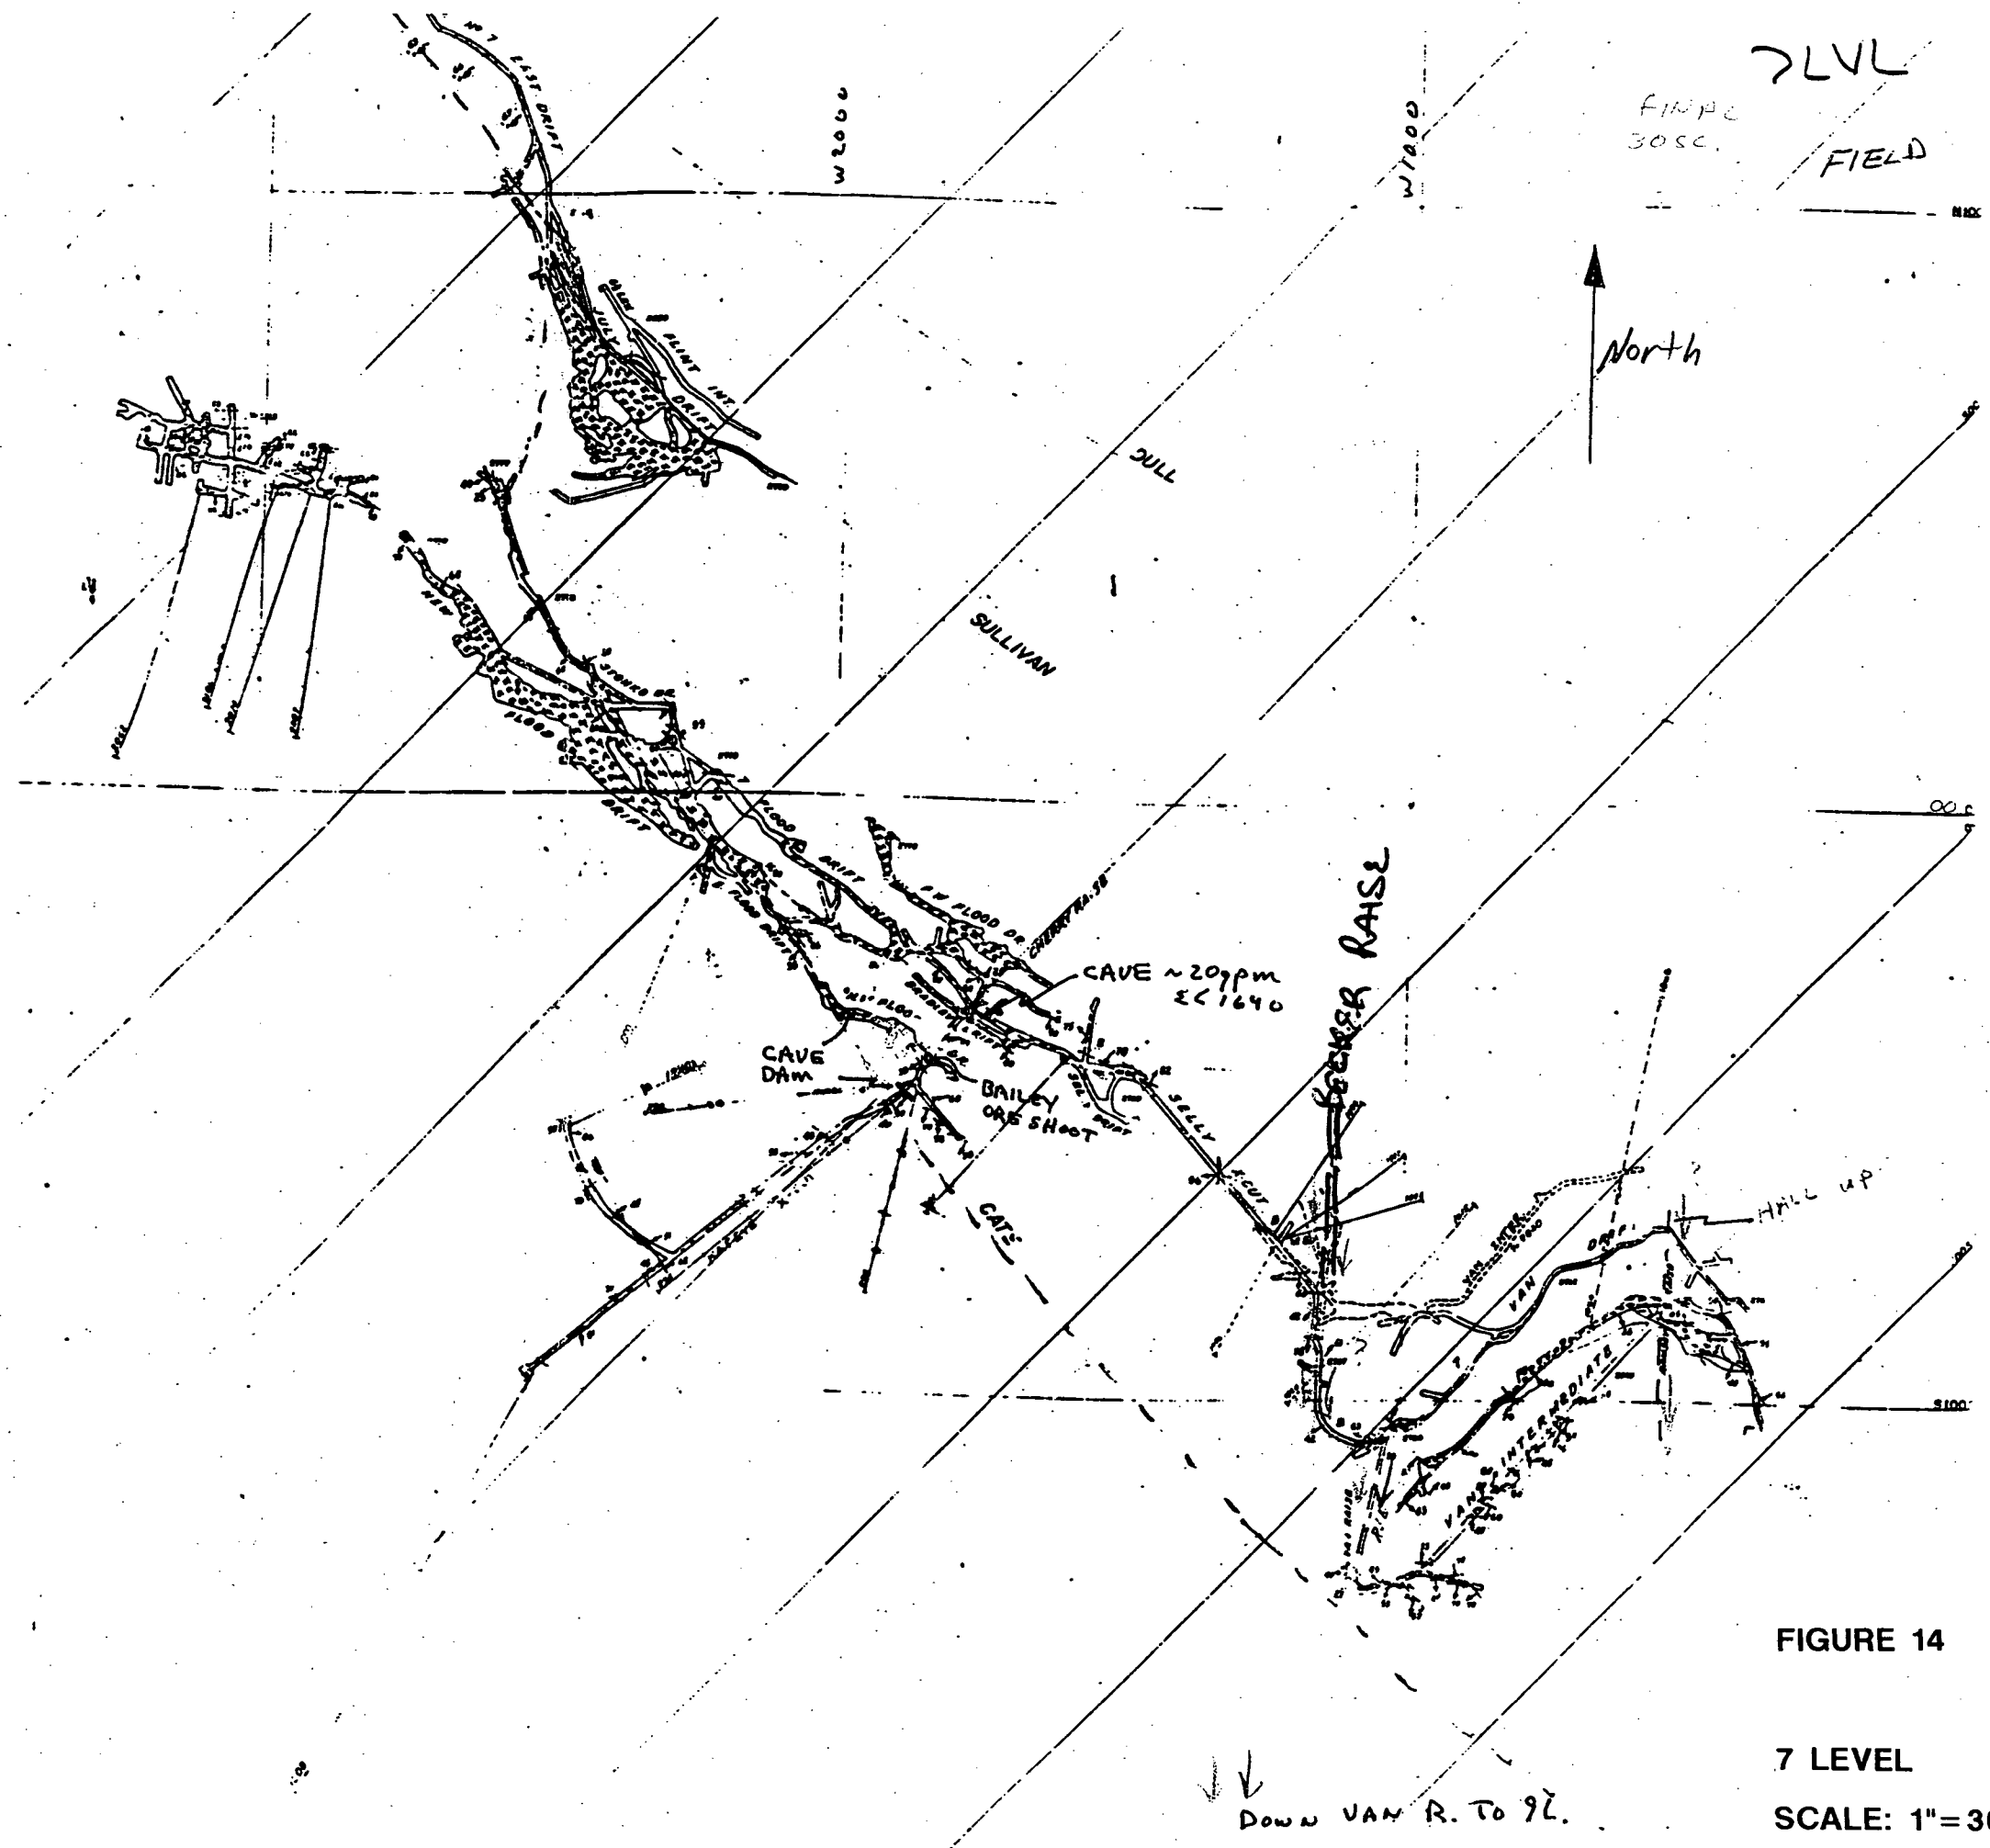
FIGURE 14

Access to 7 Level is largely blocked. A well constructed bulkhead blocks access to, and discharge from, the Flood-Stanly workings. The bulkhead probably is blocking discharge from Flood-Stanly workings and diverting it down to 8 Level via transfers or other manmade structures. The main drift in the opposite direction is also blocked.

Approximately 20 gpm of relatively good quality water discharges from the lacing just before the bulkhead (EC 1640 $\mu\text{S}/\text{cm}$). That water drains down the Cherry Raise.

The most significant flow on 7 Level comes from a single diamond drill hole at the end of the Kateye drift, straight ahead off the Cherry Raise. The water is of relatively excellent quality, with a historical EC of approximately 100 $\mu\text{S}/\text{cm}$. The typical discharge rate is approximately 100 gpm, with seasonal increases that occur mid to late summer. This water drains toward the Cherry Raise, to an ore transfer raise that discharges on 9 Level, approximately 50 feet from the bottom of the Cherry Raise.

A special case of drill hole plugging is the high capacity (high pressure?) drill hole on 7 Level. That hole discharges more than 100 gpm of relatively excellent quality water. This discharge contributes to the hydraulic load at the treatment plant. Another serious consequence of this discharge is its impact on ditch and track maintenance underground.
